## THE WENDOVER ARM TRUST WORKING PARTY NEWS

ISSUE 88

December 2011

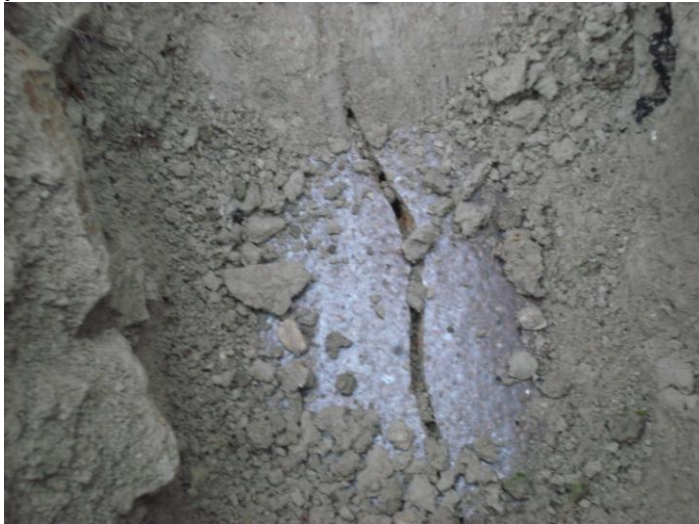
### TYPICAL LONGITUDINAL CRACK IN THE 18" PIPE

In April 2005 trial trenches were dug at the 100 metre markers to determine the position and depth of the 18" earthenware pipe carrying the water from Wendover under the canal bed. At that time several of the exposed pipes had longitudinal cracks along the crown of the pipe. Although the pipe generally runs on the offside of the canal, a year or two back an unknown manhole was found at the foot of the towpath bank at chainage 3622. We knew that at chainages 3500 and 3600 the pipe was on the offside at these points so it was decided to dig additional trial trenches to determine the exact route of the pipe in this area. To pipe cap where the pipe crosses the bed of the canal means cutting off access to the Drayton Beauchamp end and has to be carefully timed.

This investigation was successfully completed and it demonstrated the deterioration in the pipe after 100 years as shown below:

The state of the pipe also explains why BW gave the Trust £200,000 towards restoration of the canal back to normal water level in lieu of the essential maintenance cost of renewing the pipeline.

- BW/CART will then investigate potential weaknesses in the banks and carry out essential maintenance work to cure any problems.
- The sump at Drayton Beauchamp will require sealing and this will leave the 18" pipe as a land drain beneath the canal to relieve any potential hydraulic pressure below the waterproof lining. It will drain into Tringford Reservoir as now.

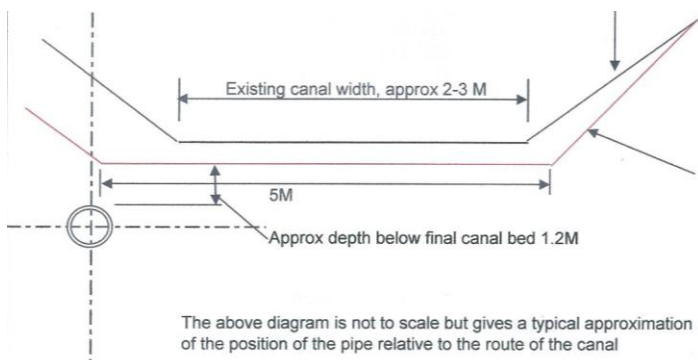
It should be noted that the pipe shown in the photograph is under the offside bank clear of any restoration activities as shown in the cross section above that records the results of this month's investigations.

The cross-section, that shows the excavation for the new lining in red, indicates how much it is necessary to cut into the offside bank to cap the pipe trench. This involves a great deal of excavation and subsequent backfill that then has to be left to consolidate before bank lining can progress.

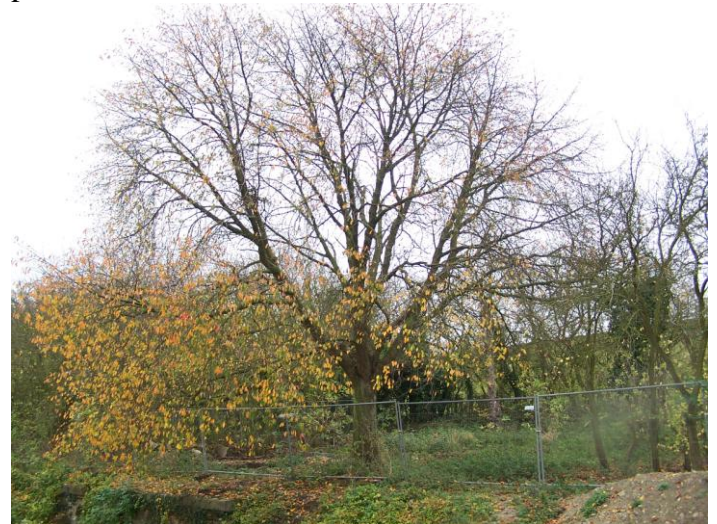
### **THE PRUNUS TREE AT WHITEHOUSES**

In examining the site BW expressed concern over the roots of the prunus tree that dominates the site at present.

The pipe from the present manhole on the 18" pipeline to the pumping shaft lies between the prunus tree and the settling tank. Substantial roots from the tree are already intruding into the settling tank.

Prunus trees are not known for longevity, they have a limited life span of up to about 80 years.

In case it becomes essential to remove the tree, something we hope will not happen yet, Margaret Leishman has taken some hardwood cuttings in the hope that these will take and enable us to replace the tree in a more suitable location with an original off-shoot in the future. As a member of the RHS, Margaret has since contacted their members' advisory service and they say that the only easy way to get a true replica of the original is to take a hardwood cutting during the winter, and has sent her detailed instructions. Margaret is going to take further cuttings based on this advice.
