THE WENDOVER ARM TRUST WORKING PARTY NEWS

ISSUE 105

October 2014

September and October Working Parties

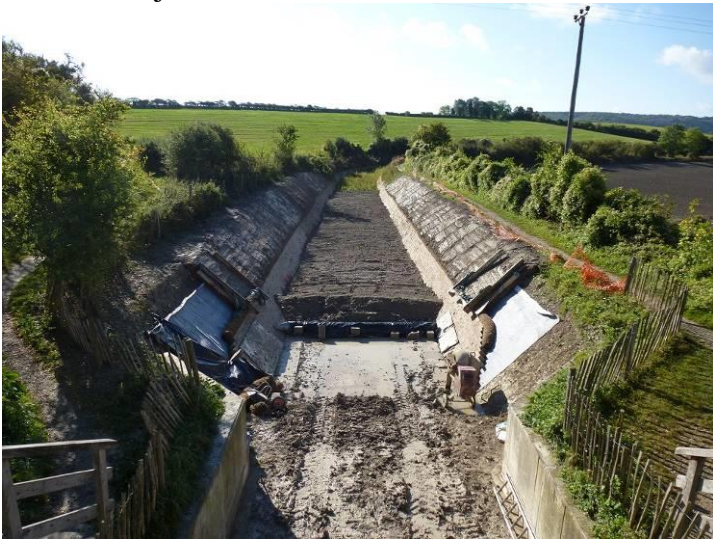
Apart from lining the throat of the bridge narrows, all lining leading up to Bridge 4A was completed during these working parties as shown below. The good weather was, believe it or not, the reason for not completing this work at the September working party. Laying very dry spoil on the sloping banks was a slow and tedious job.

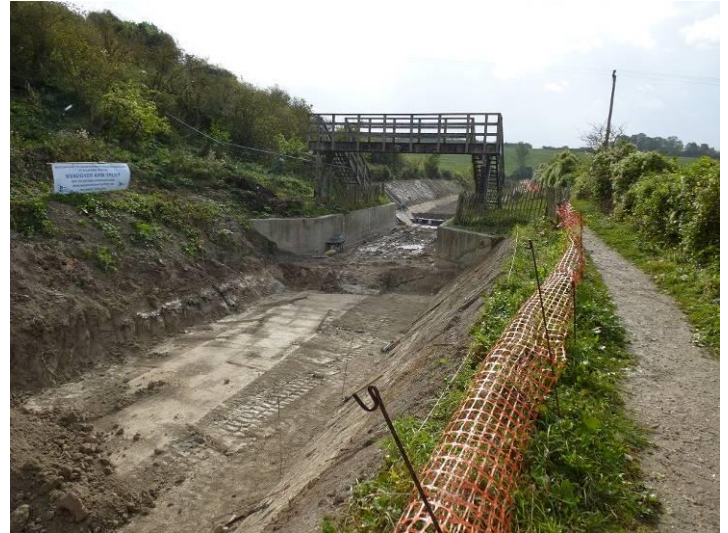
This picture taken on the last day of the October working party shows the completed profiling of the towpath bank and bed ready for 10 metres of lining past the bridge. Work has commenced on rough clearing the offside ready for profiling this bank.

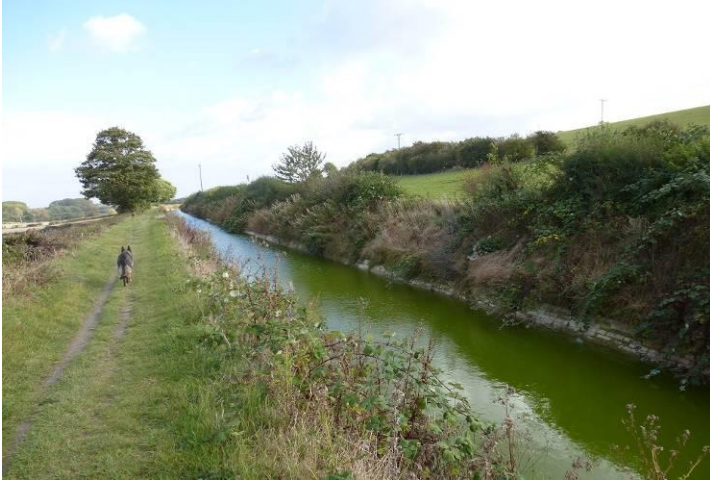
This picture illustrates how low the water has dropped. The concrete block lining should be under water but the level is at least 18" below its usual level.

Another very serious state of affairs resulting from the lack of water at Drayton Beauchamp is that the Trust's re-watered Stage 1 is receiving no water and is slowly evaporating due to wind and hot weather. If we had completed the bund in Bridge 4A this year we would be struggling to put any water in our newly re-lined length!
