THE WENDOVER ARM TRUST WORKING PARTY NEWS

ISSUE 112

December 2015

November and December Working Parties

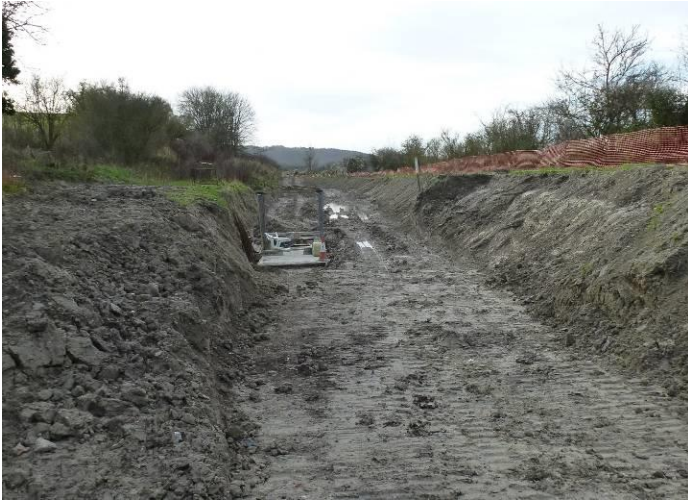
This photograph shows the progress at the end of the December working party.

This picture, taken from in front of Whitehouses, shows the completed pipe capping on the left that is now approaching the end of Stage 3 at Whitehouses.

On the offside, behind the pipe capping is the bank being restored in carefully laid shallow layers of spoil that are consolidated by the plant operating to and fro over it. The bank had to be removed to allow the pipe trench to be capped although, as stated in the October issue of this newsletter, the bank was mainly spill from the Herts County Council former rubbish tip adjacent to the canal. On the towpath side the bank is being rough profiled ready for the re-lining process in due course.

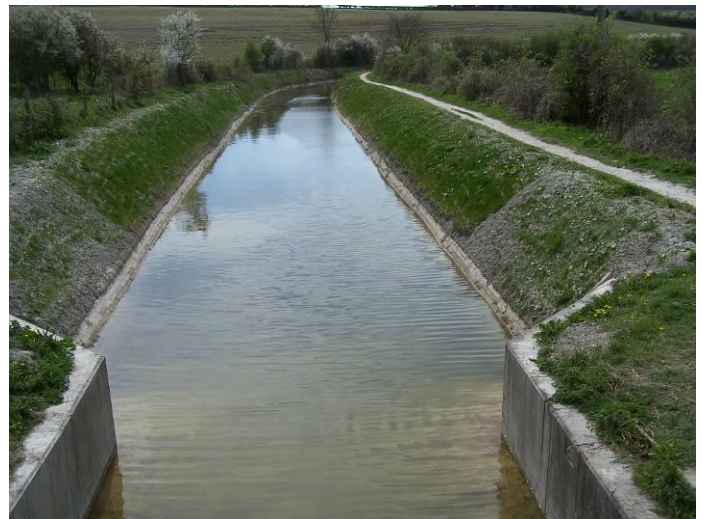
I can only look back with pride for what the Trust's volunteers have achieved in eight years, a total of 550 metres in water since re-lining Phase II started in 2007. The Trust will be saying thank you at a buffet lunch for our volunteers in January.

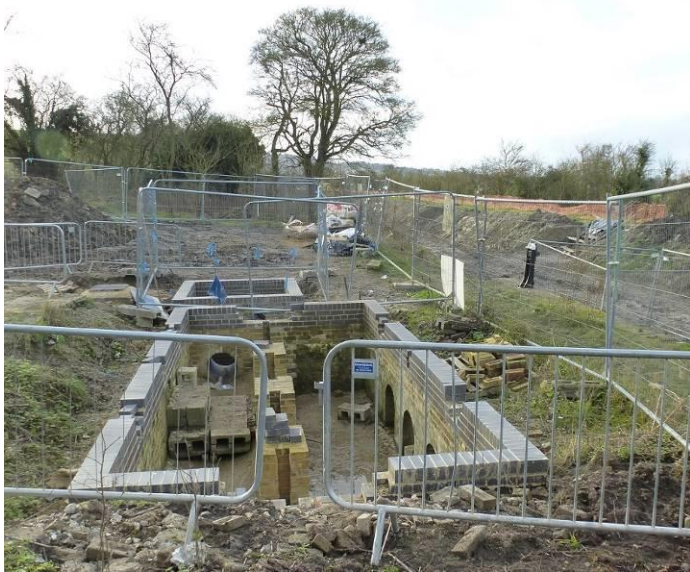
The CRT contractor has been working on the water control works although work has been temporarily suspended at present.

This photograph shows the present progress. The settling tank in the foreground is ready to receive the cross members that will support a steel grid over the tank

The brick piers in the tank, part of the restoration by KESCRG, with grooves are to hold weir boards to control what will be the water level in the whole of the Arm and the mainline canal (Tring Cutting) between Cowroast and Marsworth locks with surplus water being fed into Wilstone Reservoir.

The square brickwork behind the settling tank is the new manhole that will have sluice valves to control the various flows of water.

Reinstated in its original position on top of the wharf wall is the paddle gear that will allow the pound between Bridge 4 (Patrick Saunders footbridge) and Bridge 5 (Drayton Beauchamp Bridge) to be drained. It has been refurbished in newly painted black and white.
