Wendover Arm Trust

Operations Report 28 April 2021

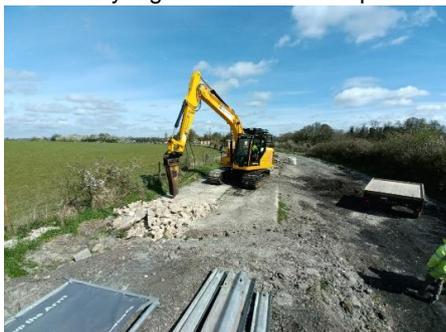
The first step of clearing the Tip surface with a Hydraulic pecker!

The whole of the surface of the tip has been cleared to allow subsequent excavation and disposal of the tip contents. The first item to be broken up and removed was the reinforced concrete cutting pad that had been used for rolling out and cutting up the Bentomat (hence the Bentomatic!). This had obviously been made to a remarkably high standard and required all the might of the 13 tonner and a large hydraulic pecker to break it up.

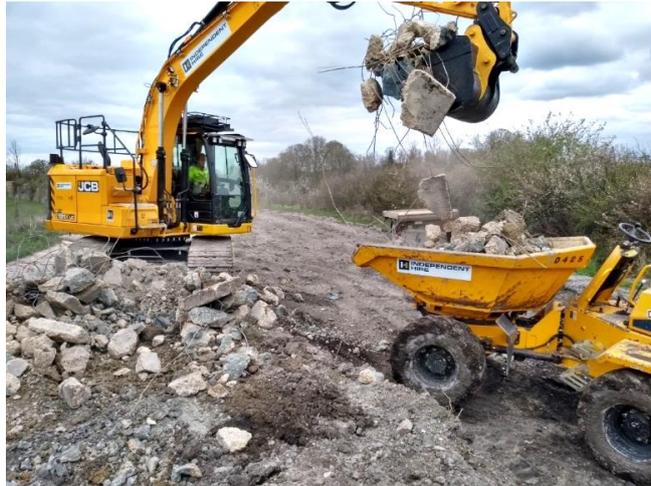
The steel reinforced rubble is taken away to a stockpile awaiting removal by a grab truck

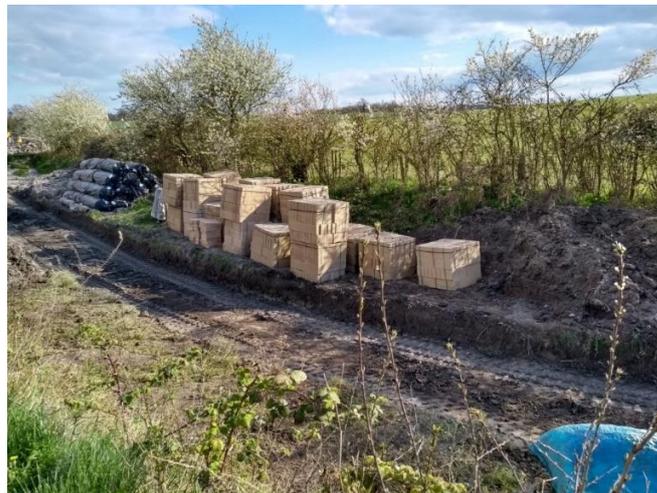
Coir rolls and concrete blocks in their new storage position.

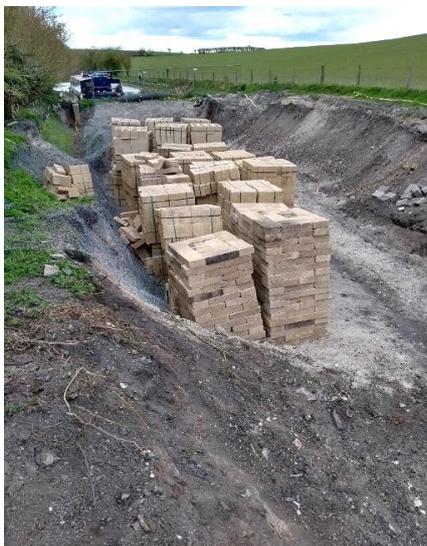
Yet more concrete blocks stored at the Excavated Tip end near to the Winding hole

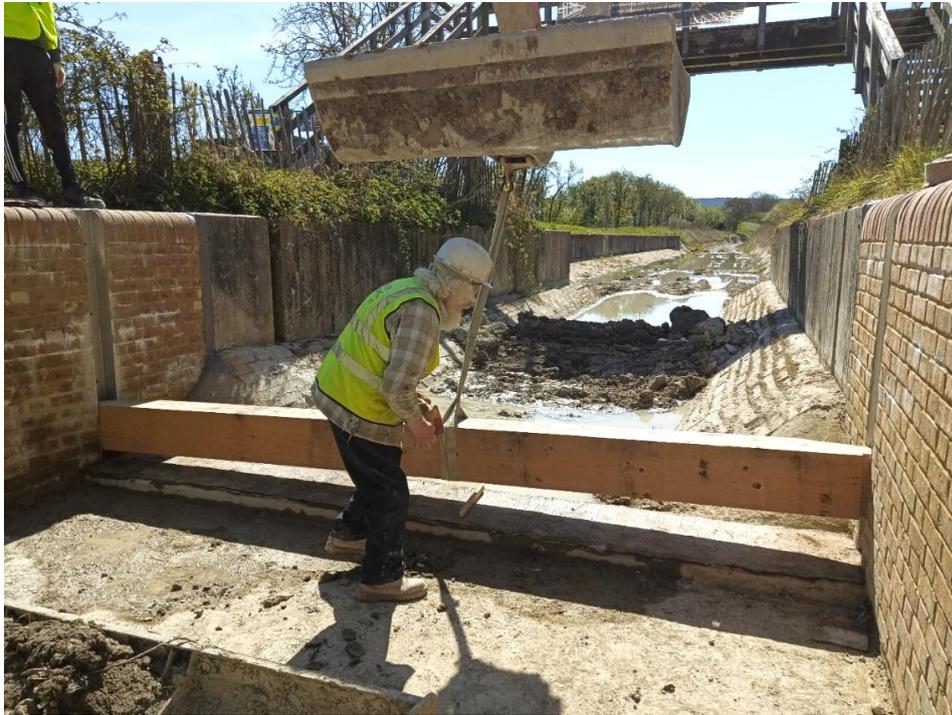
Here is the first plank being put into position

After some adjustments to the stop planks, they were taken down to the Bridge 4 site and installed in the channels built into the new walls. The first plank was laid onto a piece of Bentomat to aid sealing to the concrete up stand cill.

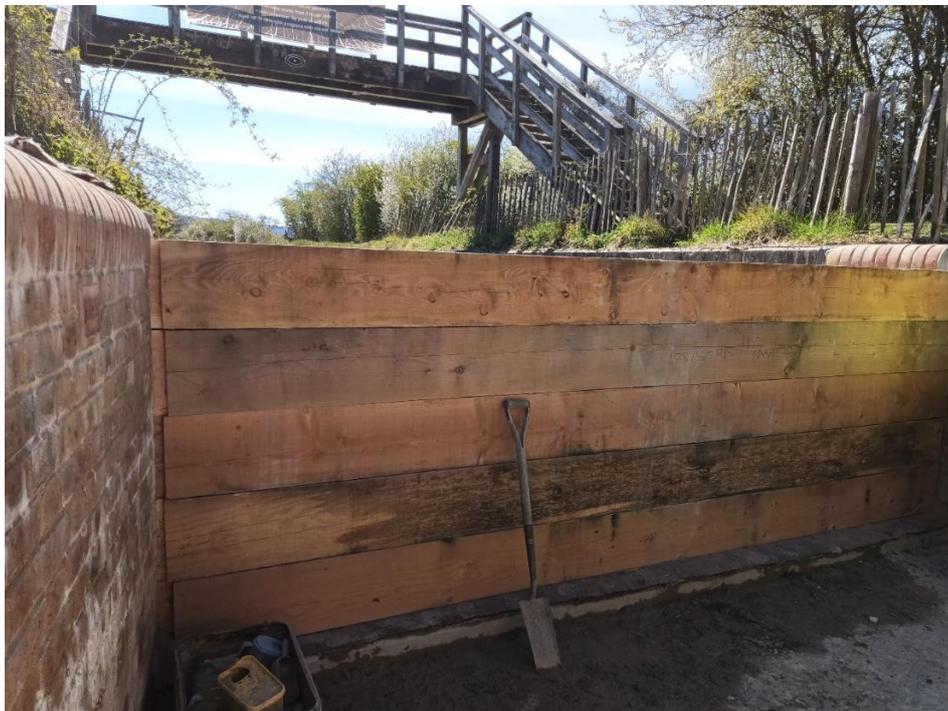
And here are all five planks ready to have Oak wedges put in at each end to hold them in place when under water.

The back of the planks was sealed with a single layer of Bentomat to provide as much water proofing as possible. A tarpaulin will be further added to make sure the seal is as good as we can get it.

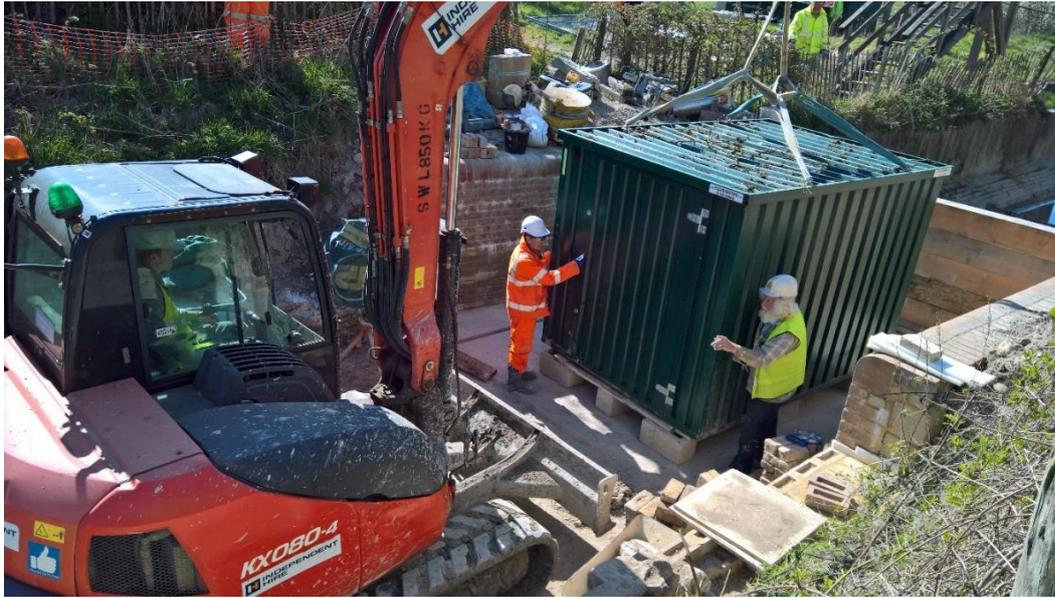
The old wall remains on the offside can be seen here

With the stop planks fitted, the hut could now be moved on to the concrete slab. This will allow the excavation of the soil covering the remains of the swing bridge wall on the offside so that the brick work can be restored and rebuilt.

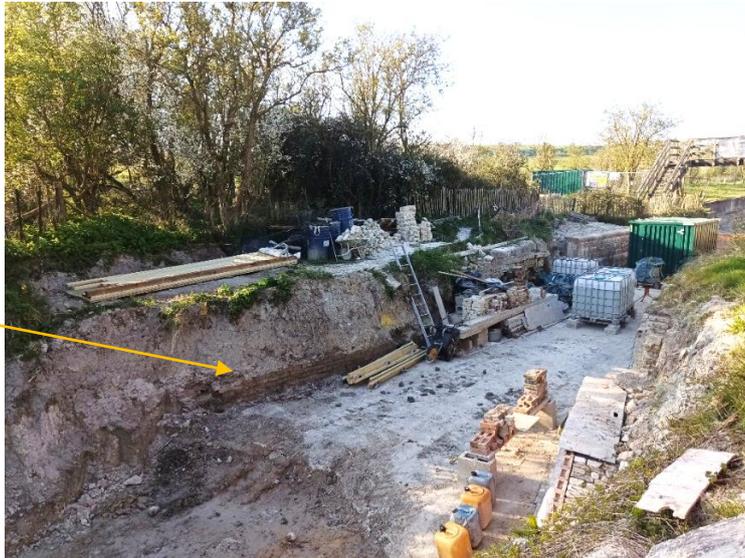
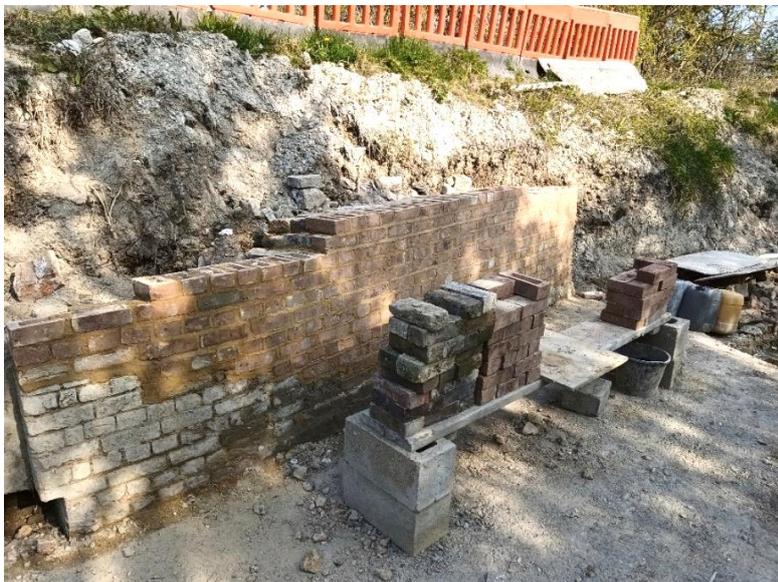
New brick work grafted onto the old. Lime mortar is being used

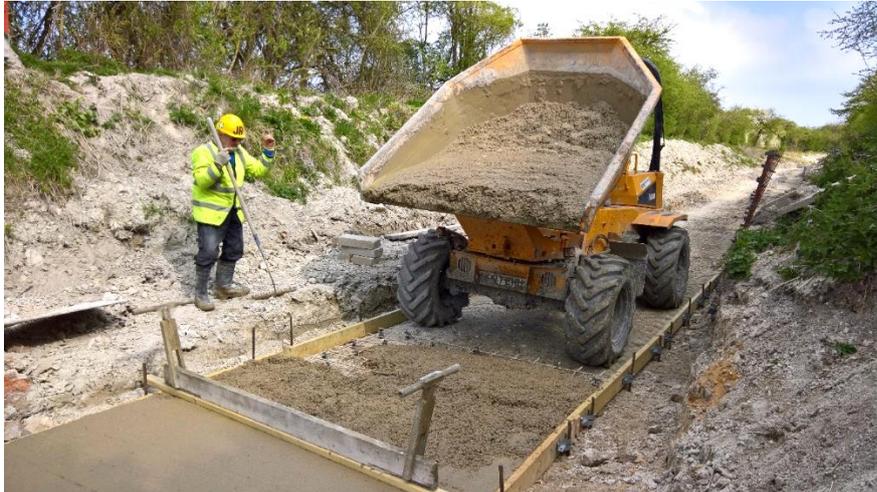
Here we have the form boards held in place with steel pins and a wedge system to make the height adjustment easier.

Reinforcing sheets have the "chairs" added and are then put into the poured concrete and tamped into position.

Now that the length from bridge 4 to bridge 4a is completed the attention has now turned to starting the excavation and lining of the section from bridge 4 through to the Tip. The first stage is to prepare and cast the pipeline capping to provide protection to the Bentomat liner should the pipeline collapse. The capping will also be used as a "road" for completing the remainder of the lining activity. This will eliminate the usual water and mud problems over the next wet period. As can be seen in the pictures, the capping is now being made wide enough for a 6-tonne dumper to run between the form boards, it will also be wide enough for an 8-tonne excavator to run on.

With this process the volunteers were able to transport the 4 cubic m of ready-mix concrete for 800m along the canal bed and finish the tamping in around 40 minutes! Based on this success the amount of form work will be tripled. We have a lot of pipe capping to do!
