## Operations report October 2021

Wendover Canal Trust

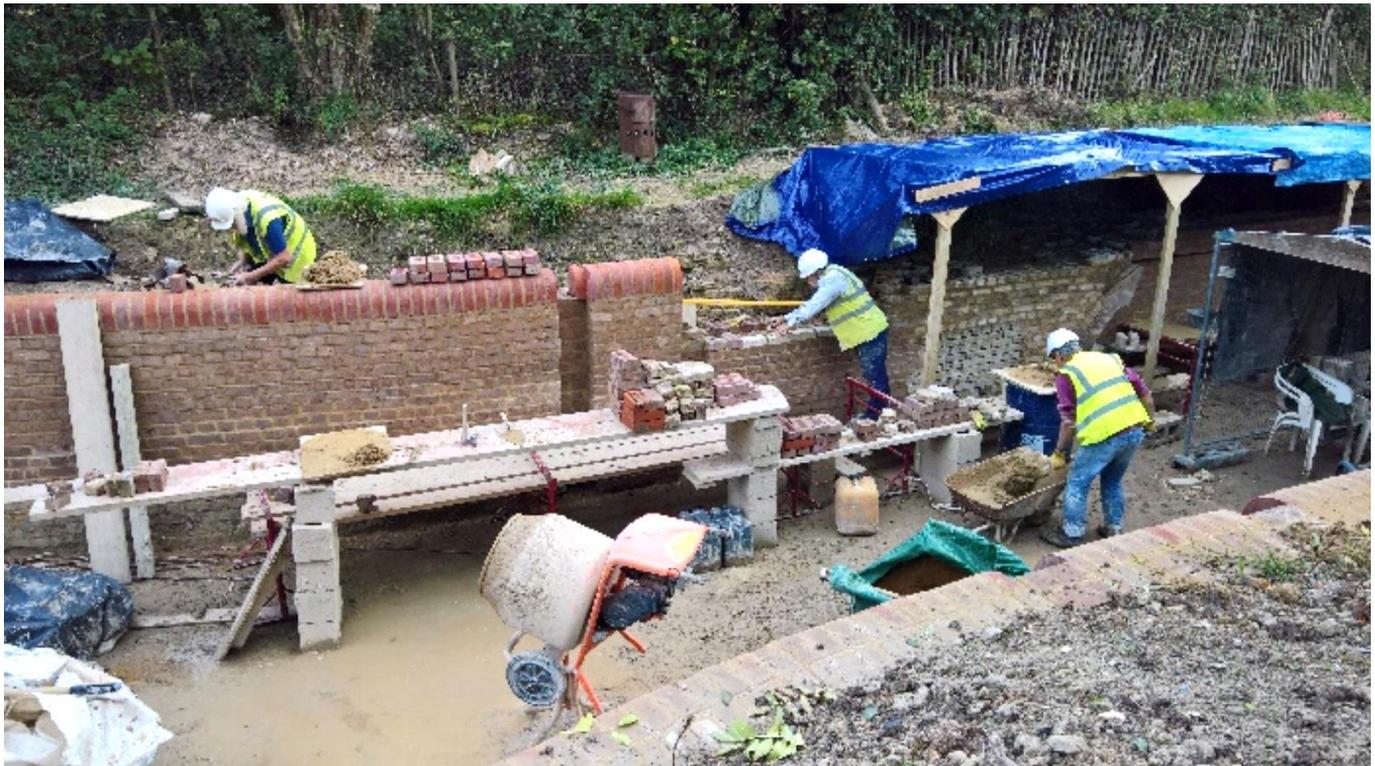
The offside wall is coming along nicely!

For those of you who have been following our progress, the towpath wall has been finished, including various brick features and stop plank grooves. Whilst we know what the stop plank slots were there for, we don't know why most of the brick features are there. Maybe the walls have been rebuilt and modified over the years.

Many photos were taken of the offside wall before it was carefully demolished because it was beyond simple repair and also unsafe. All we have to do now is to follow the pictures and the towpath wall

example and rebuild it all, including the curved “lead in wall” whose foundations were only found relatively recently.

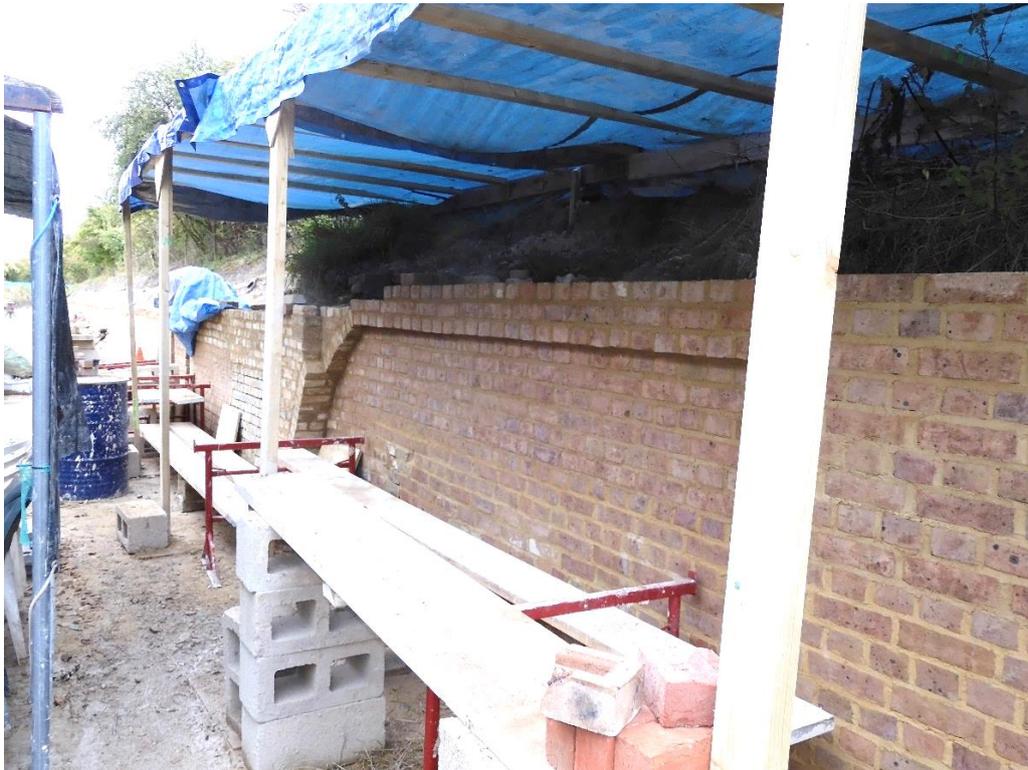
Here we can see part of the “features”, including part of an arch, being rebuilt.

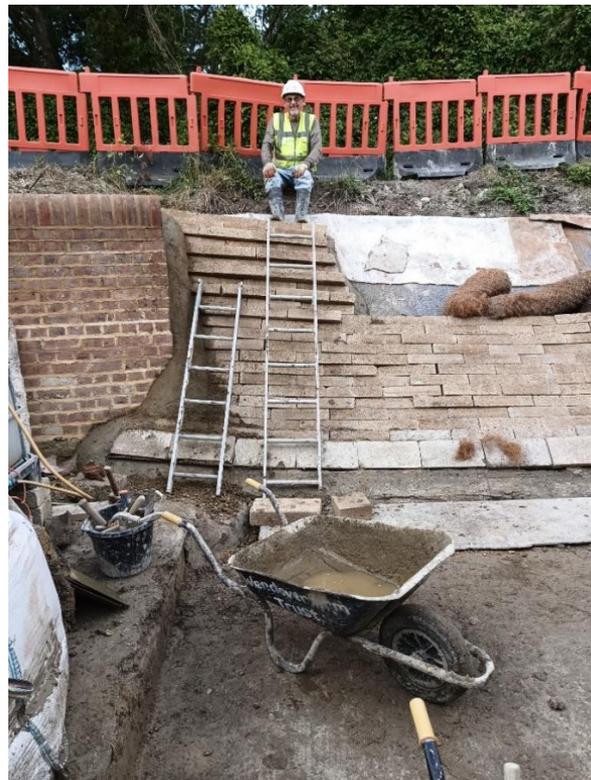
Bob looks pleased to have finished the animal steps and takes a short rest.

We took the decision to introduce what we call “dog steps” some time ago. It seems that dog walkers were happy to let their dogs go for a swim in the rewatered canal sections, but we weren’t so happy to see that the dogs scabbled the bank away when it was time for them to get out of the canal. The most wear and tear occurs at features such as bridge abutments and mooring walls where the sloping bank is the first opportunity for animals to get out, since they can’t climb the vertical faces.

We also know that many other animals need to cross the canal, and some may fall in accidentally and need a way of getting out. The concept is simple. We put in a few rows of concrete blocks with every other layer pushed forward to make a step. Concrete has been used behind the “raised” blocks to make sure they stay put. When the canal is in water the bottom step will be at water level. These features will be placed at intervals along the bank and at the ends of any bank structures

Some concrete can be seen between the “steps” and the brick wall. It is there to make sure the Bentonite paste water seal, between the Bentomat waterproof liner and the wall, is protected from damage and doesn’t move in future.

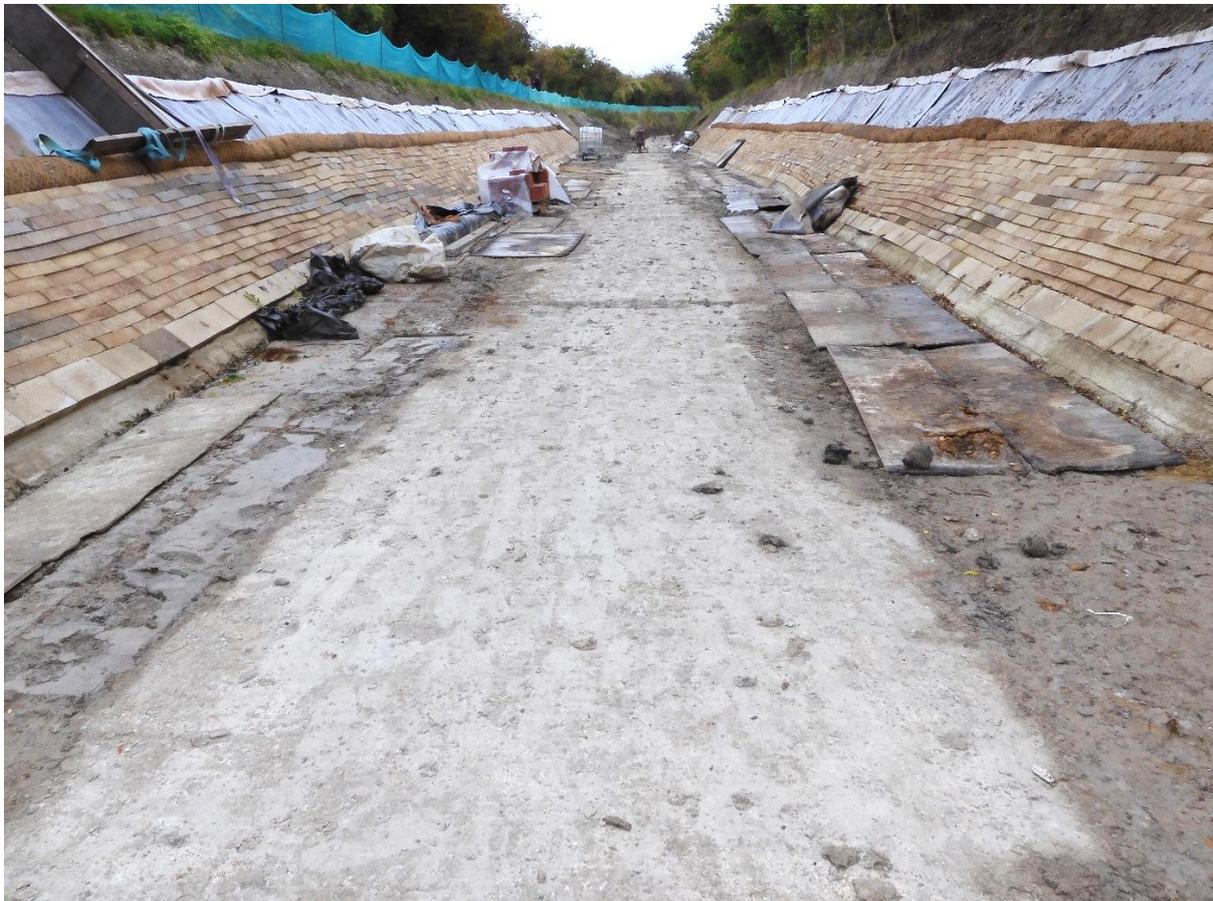
Looking towards Little Tring from Bridge 4. In the centre is the concrete pipe “roadway”. On either side the Bentomat lining and solid blocking has been extended even more!

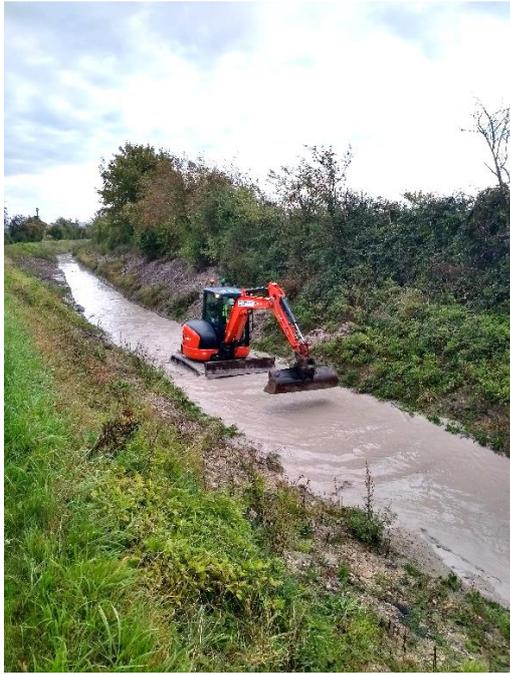
Again, for those you who haven't seen this before, this is the working conditions in the same place a year ago! (300mm plus water depth)

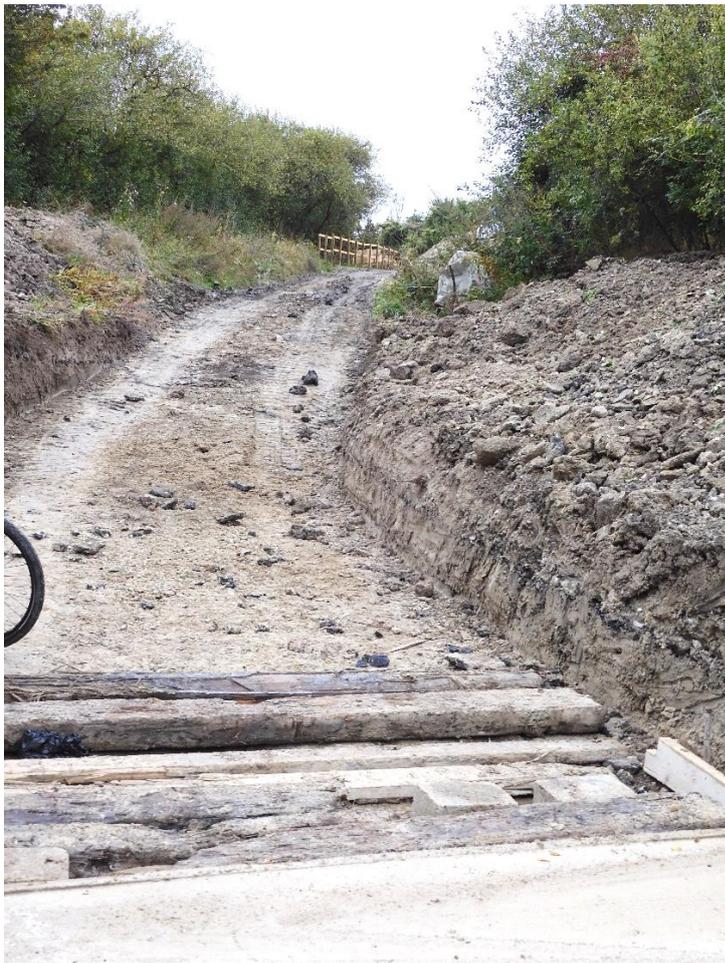
Pipe capping /Concrete roadway

Yes, it does look like more mud! But this is the new end of the concrete pipe capping/roadway, and we can now see the fence at the beginning of the old refuse tip.

The reason for the pipe capping/roadway is that: - where the glazed ceramic pipeline to take water from Wendover to the pumping station still exists (starting at Drayton Beauchamp), it represents a long-term possibility of damage to the new Bentomat lining system should the pipe collapse. The canal bed was excavated and more concrete laid to extend the roadway/pipe capping. As the picture shows we are now reaching the area where the historic refuse tip starts (also our car park and storage area!). The capping/roadway now extends some 500m from bridge 4. We are now making a roadway only (no pipe underneath) because the pipeline makes an exit through the bank to Little Tring pumping station, at the place where the concrete was laid last month. The roadway will help to overcome the winter mud problems that have been an unpleasant feature of restoration for many years!
