# THE WENDOVER ARM TRUST

## WORKING PARTY NEWS

ISSUE 103

June 2014

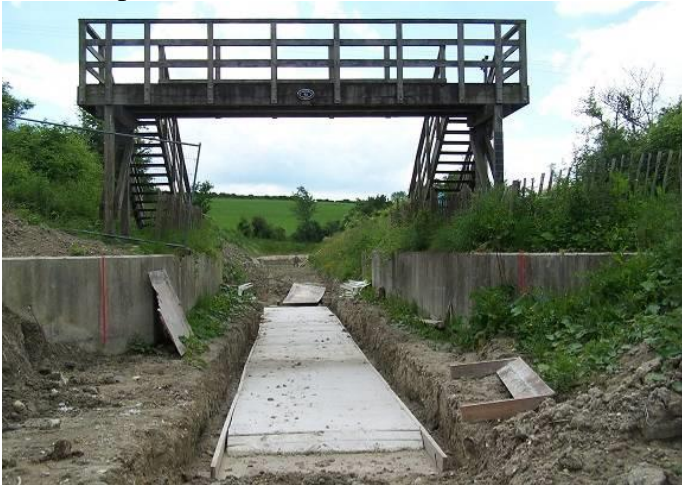
### **COMPLETED PIPE CAPPING**

Having prepared for the higher level pipe capping through Bridge 4A at the April working party the May working party completed the pipe capping through the bridge narrows with three ready-mix concrete pours.

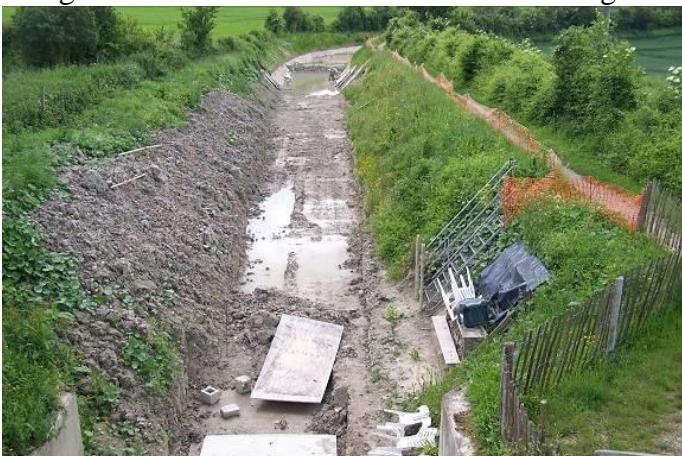
The way ahead is now clear to line the canal up to Bridge 4A. As shown below there is not far to go.

In June enough of both banks were lined with Bentomat, blocks and coil rolls laid and spoil placed above to enable another 20 metre roll of Bentomat to be laid along the canal bed and covered with spoil.

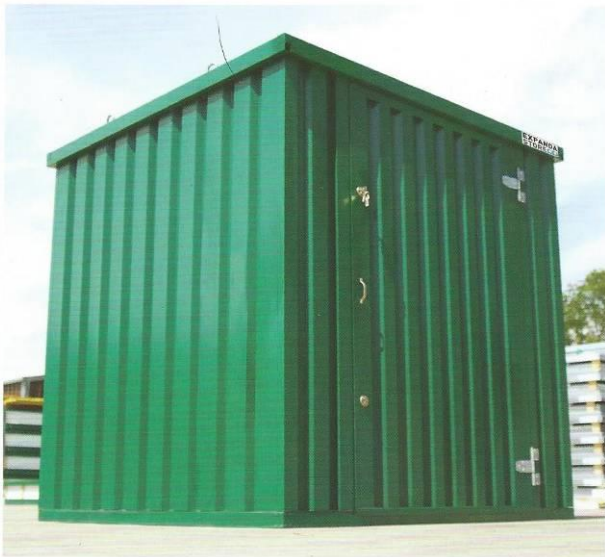
**EXPANDA  
STORE**

Several options have been looked at and the best solution, bearing in mind that we have to transport the cabin along the bed from Little Tring, is a flat pack cabin that has internal bolts for assembly, a strong floor and a drained roof. It is double locked and 3metres by 2.1 metres. It is said it only takes 1½ hours to erect once a base has been prepared.

This model illustrated is 2 metres by 2.1 metres. It has been decided that the 2.1m x 3m size will suit our purpose and it is being ordered with a view for delivery in September with the intention of moving the flat pack parts to Whitehouses at the September working party. If there are surplus volunteers at the working party the cabin can be erected in a day, otherwise a special day will be arranged for the installation clear of the working party dates.
